Manhole Inspection Summary

Manhole # S07KK1024MH

Insp Date: **12/23/08 4:13 PM**

Location Address: **3803 LEWIN AVE**

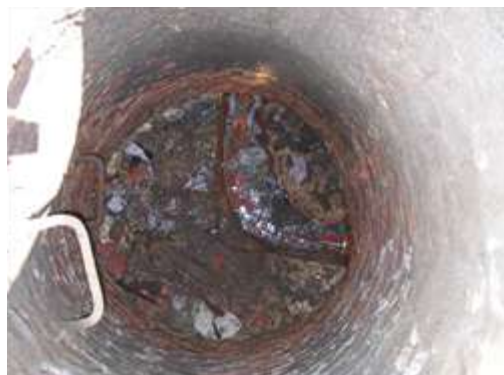
Top View

DEBRIS ON BENCH AND IN CHANNEL

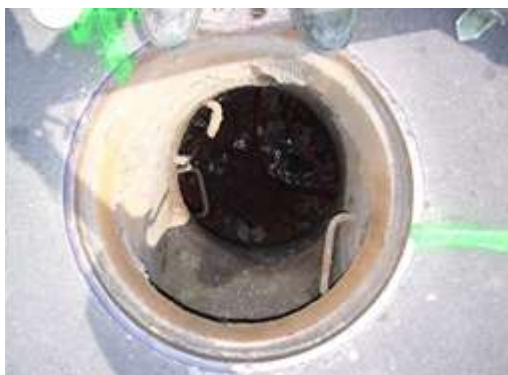
Top View

Steps Count: **4** Missing: **1** ☒ **Corroded**

CORRODED STEP

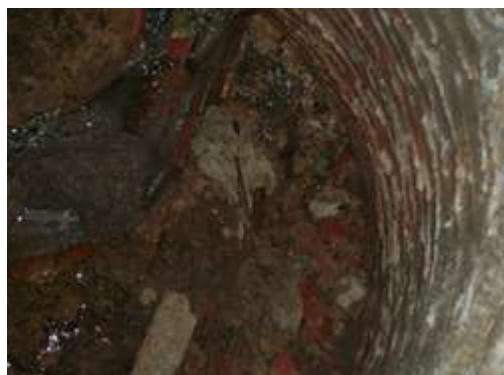
Defect 4

Surcharge ☒ **Evidence Of Surcharge** Depth: **2** (ft.) ☐ Active Surcharge Present

EVIDENCE OF SURCHARGE

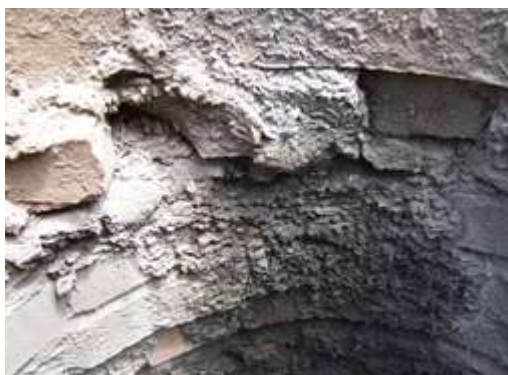
Defect 3

Condition: ☐ Sound ☒ **Cracked** ☐ Root Intrusion ☒ **Loose Brick** ☐ Deteriorated

CRACKED AND LOOSE BRICKS IN CHIMNEY

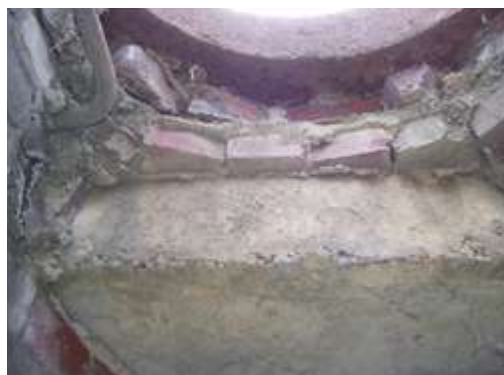
Defect 2

GRADE ADJUSTMENT

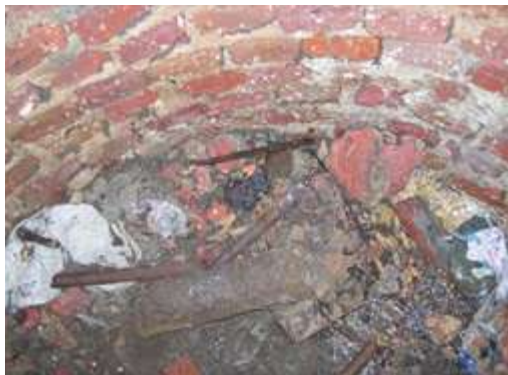
Defect 1

DEBRIS ON BENCH AND IN
CHANNEL, BARREL LOOSE BRICKS

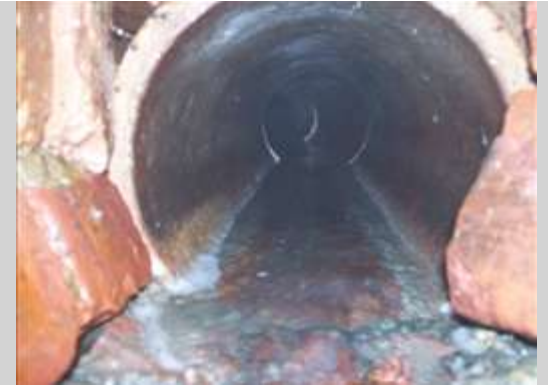
12 O'Clock Outflow

Pipe Height: (in.) Direct
Pipe Material: **Clay** ☐ Pipe Lined
Invert Depth: **10.78** (ft.) Flow Characteristics: **Slow**
Deposits: ☒ None ☐ Mud ☐ Sludge ☐ Debris ☐ Grease
Silt Depth: (in.) Deposits Extent:
Infiltration: **None** Pipe Seal Cond: **Broken**

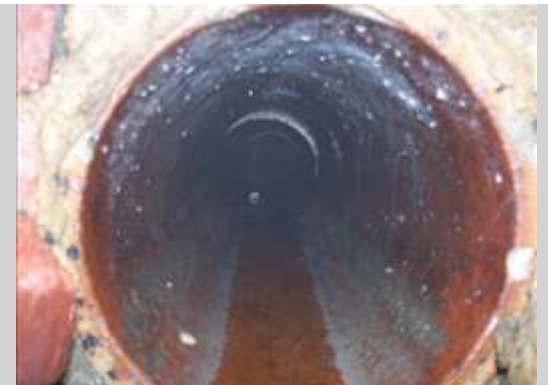
3 O'Clock Inflow

Pipe Height: (in.) Direct
Pipe Material: **Clay** ☐ Pipe Lined
Invert Depth: **10.40** (ft.) Flow Characteristics: **Slow**
Deposits: ☒ None ☐ Mud ☐ Sludge ☐ Debris ☐ Grease
Silt Depth: (in.) Deposits Extent:
Infiltration: **None** Pipe Seal Cond: **Broken**
